May 4, 2015 (Exhibit #2)

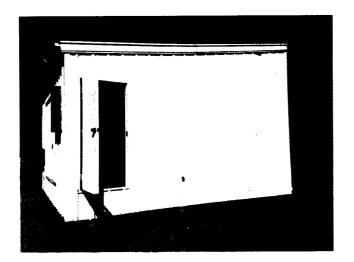
c. Penthouse Ladder – The penthouse was added however no ladder access was provided, this is a safety concern.
